Rear Axle Failure Analysis of the Dump Truck

The dump truck rear axle has failed while operating. The shaft transmits torque from the differential gear to the rear wheels through a planetary gear arrangement. Axle parts that fail to be investigated to determine the cause of failure. Field scanning is done using scanning electron microscopy (SEM). The hardness profile along the cross section is evaluated by measurement of micro hardness. Chemical analysis shows that the shaft is made of american iron steel institute (AISI) 4140 steel. The shaft carbon content is 0.52%, higher than AISI 4140 standard where the maximum carbon content is 0.45%. Manganese (Mn), sulfur (S), phosphorus (P), silicon (Si), and chromium (Cr) content have met standards. Microstructure analysis and profile hardness testing revealed that the edge profile was more fragile, different from the more resilient core. This phenomenon is related to the discovery of microstructure on the edge of the profile found in a martensitic structure which reveals that the manufacturing of the shaft undergoes a surface hardening process to harden the shaft surface. The analysis shows that the fracture starts from the edge of the

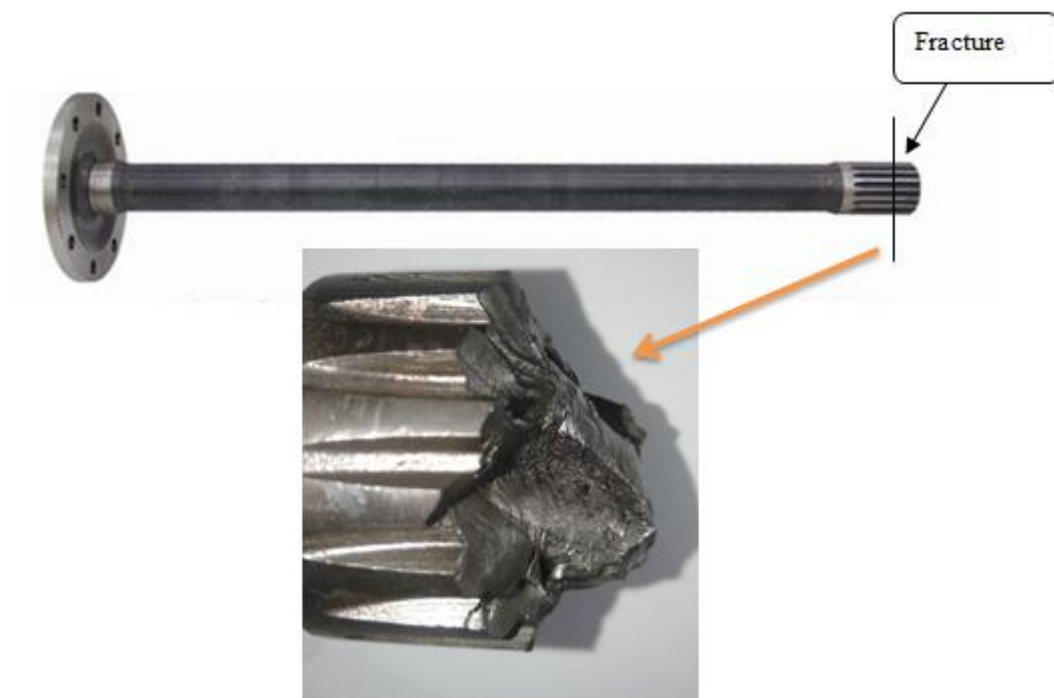
Figure 1: The Broken of the Axle Shaft whos Connected with a Differential Gear

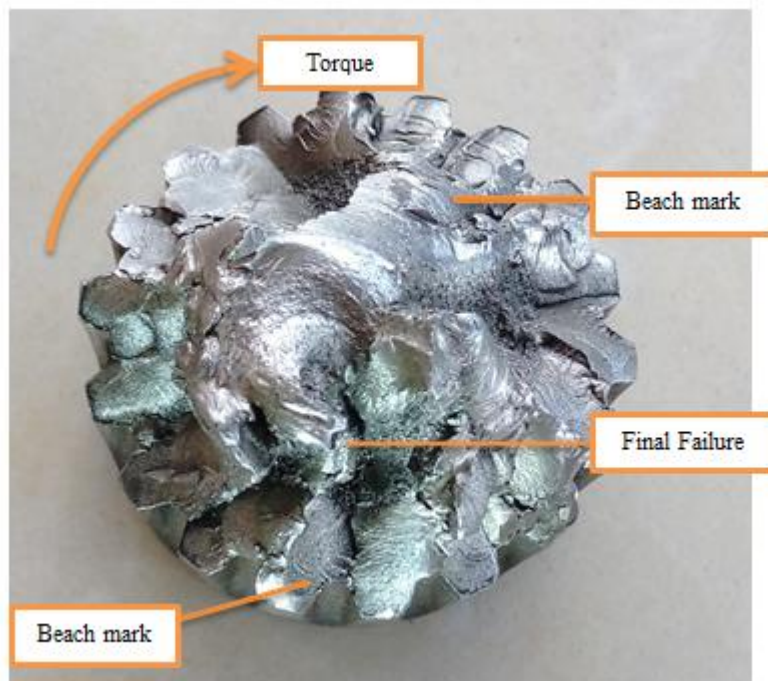
From the results of the macroscopic analysis it is seen that the crack initiation on the shaft starts from the edge of the shaft towards the center of the shaft as evidenced by the shape of the spiral in the center of the shaft that has failed. In the figure 2 there is a beach mark that is evenly distributed from the edge to the center of the shaft and the combination of slow crack propagation (dull and fibrous areas) and rapid crack propagation (areas that are shiny and slippery) indicates the shaft accepts dynamic loads.

Figure 2: Cross Section of Broken Shaft

The crack initial is indicated by striation and beach mark in the area around the crack initiation at the fault edge and appears to be rougher, while the beach mark is indicated by fine semi-circular lines in the initial crack area to final failure. Beach marks also called to be crack propagation stages. The area between the crack propagation stage and the final stage can quantitatively show the magnitude of the stress acting. If the area of the crack propagation area is greater than the area of the final fracture, the working stressing is relatively low, and vice versa if the area of the crack propagation is smaller than the area of the final fracture, the working of the

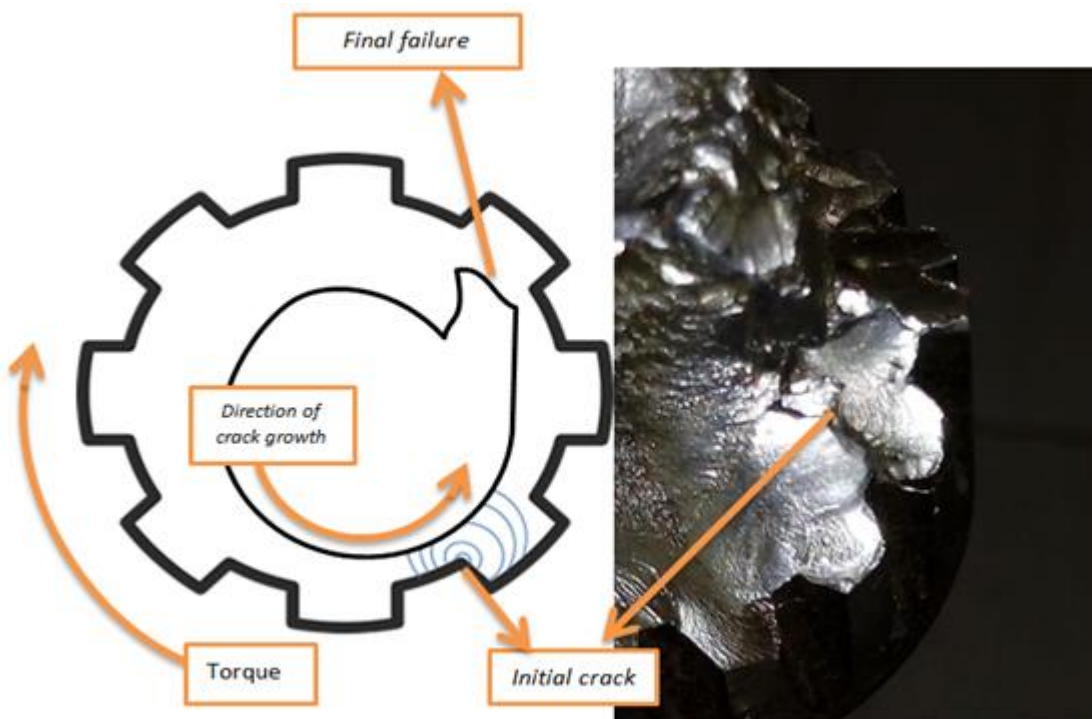
Figure 3: Initial Crack and Direction of Crack Growth

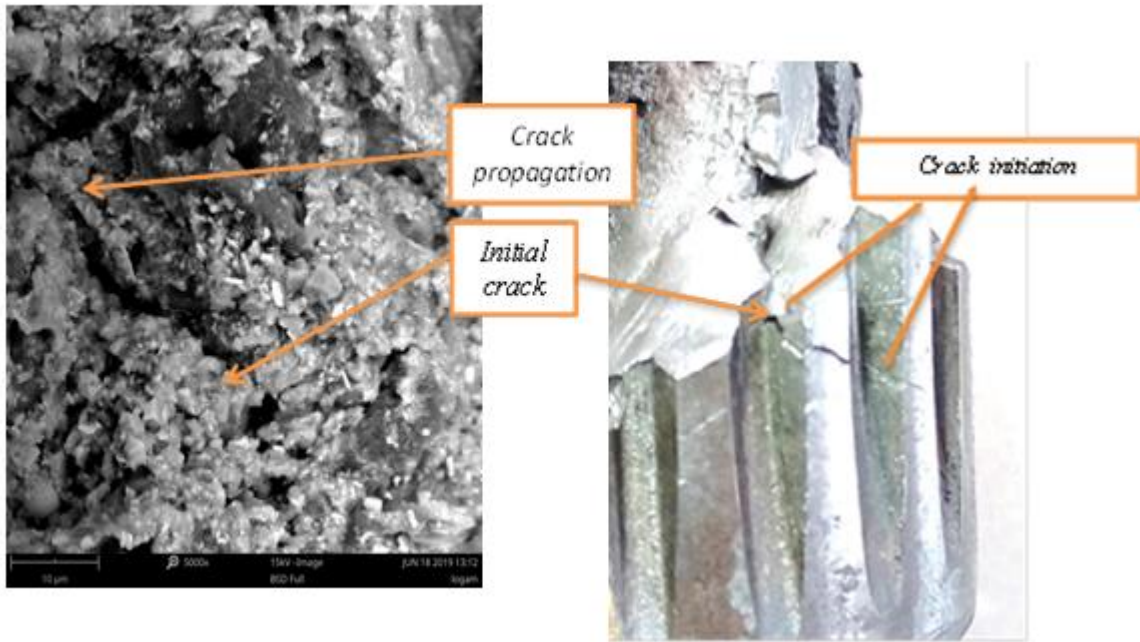
Figure 4: Crack Initiation and Crack Propagation

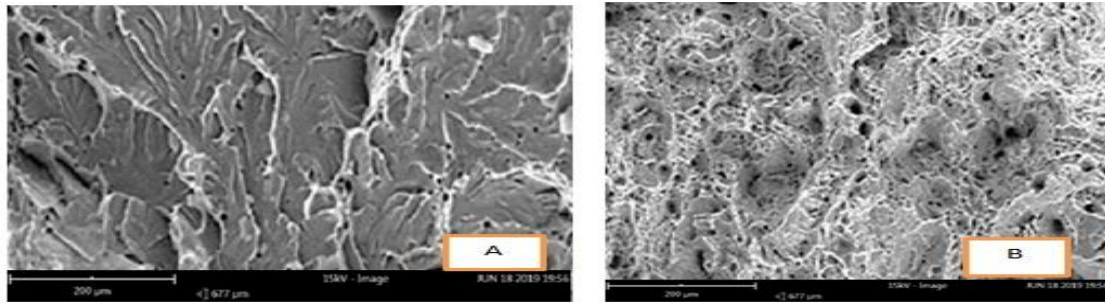
Fractography on the surface of the shaft can be seen as a V-shaped cleavage on the surface fracture, certainly broken because on brittle mode. While the fracture on the core of the shaft shows the shape of the dimples on the fault. Ascertained is an elastic type of fault. The fracture surface assessment identified several characteristics of fatigue failure characteristics: (i) a beach mark sign that is a sign of development of fatigue front cracks and (ii) a ratchet mark which is a sign of crack initiation due to high stress concentration. The exact mechanism of fatigue is always consistent with unidirectional bending. Eg: [6]

Figure 5: (A) Fractography analysis of the edge of the failed component; (B) fractography analysis of the core of the failed component.

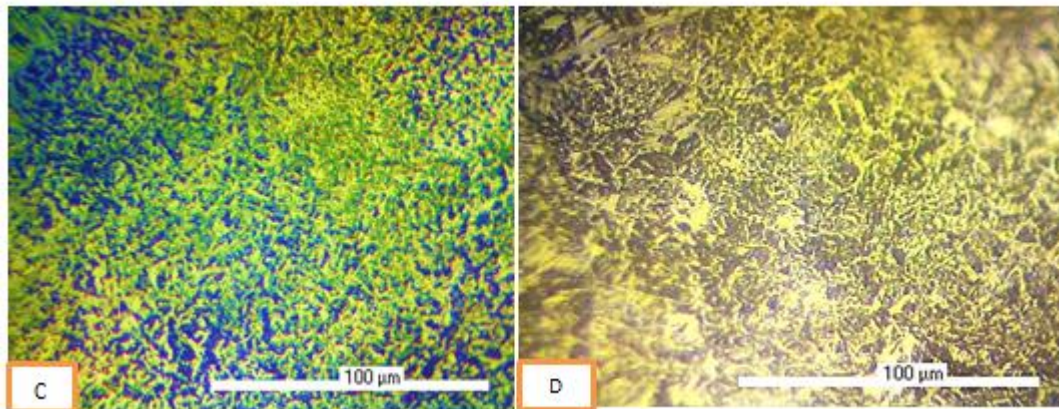
Figure 6: (C). Microstructure of the edge of the component 600x, (D). Microstructure of the core of the component 600x

Microscopic analysis on the shaft surface, Figure 6 C and 7 C, show that the martensite phase is uneven tends to be grouped. There is a ferrite-pearlite phase on the sidelines of a martensite group, indicating the temperature at the surface hardening process is unstable. The matrix area shows that the dominant martensite phase is rough and sharp so that it can be concluded that tempering is carried out at high temperatures and quite a long time and is quenched quickly. This grouped and uneven martensite phase results in uneven surface hardness of the shaft.

Analysis of the core of the shaft, figure 6 D, show the dominant ferrite and pearlite phases. It was concluded that the core of the shaft was more resilient than the surface of the shaft which was dominated by the hard bainite and martensite phases.

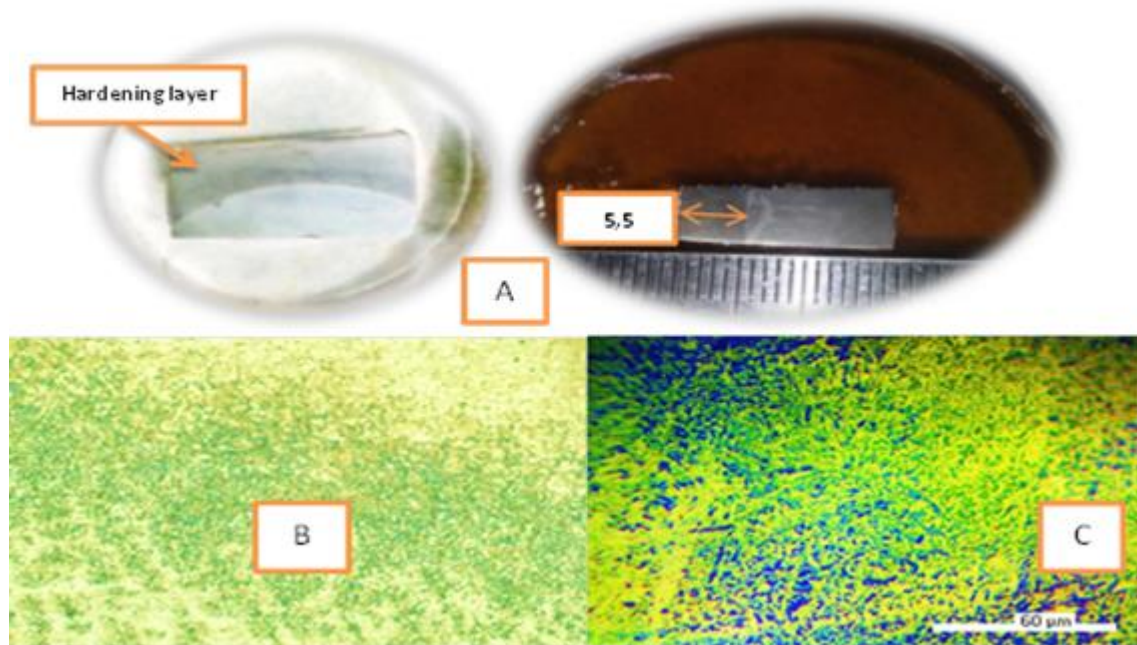
Figure 7: (A). Macrostructure of the cross section of the failed shaft, (B). Microstructure of the edge of the component 50x, (C). Microstructure of the edge of the component 600x

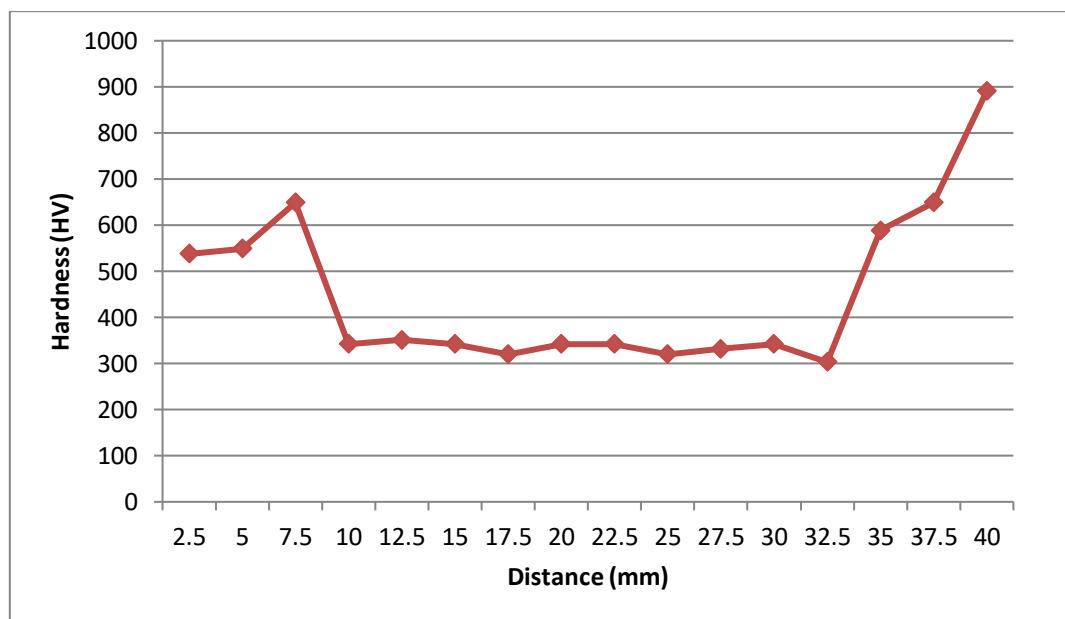
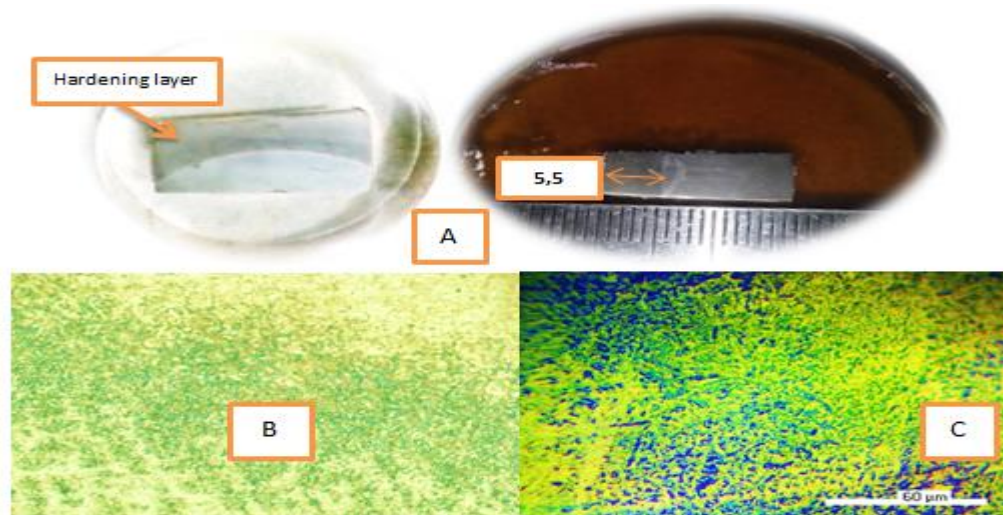
Figure 8: Rear Axle Hardness Distribution A

The distribution of the hardness values observed in Figure 8 does not look uniform. Surface hardness on different left and right sides is different, namely 538 HV and 891 HV indicating that surface hardening is not evenly distributed on the shaft. The distribution of the hardness value observed in Figure 9 There is a fluctuation in the value of hardness which is tested 2 mm from the edge (surface) by 40 circular points using a Vickers hardness tester. The highest hardness value is 885 HV and the lowest is 548 HV.
